Our Project No. : 206-09-06-0044717

SUBJECT: TESTING OF SCAFFOLD CLAMPS

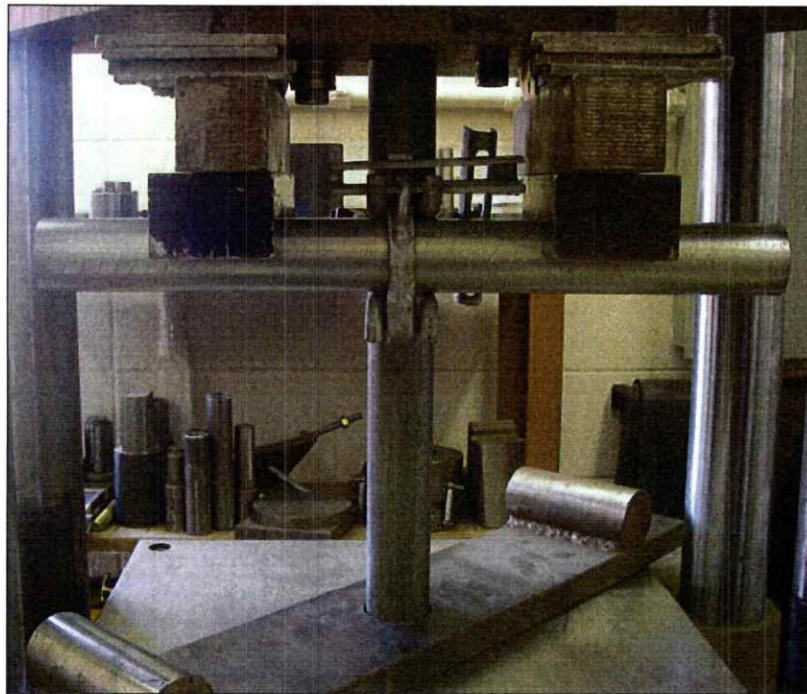
FIGURE 1 RIGHT ANGLE CLAMP TEST ARRANGEMENT

Distortion tests were performed according to Section 11.3.3.2 of CSA S269.2 and the test arrangements were set up as per the force diagrams in CSA S269.2 Figures 3 and 5. A photograph of a typical test assembly for the right angle clamps is shown in Figure 1. During right angle distortion test, compressive forces were applied to the horizontal reference tubing while the vertical bar was pressed against the bottom cross-head. A steel abutment was utilized on the vertical reference bar to support the coupler during the distortion test. The first right angle clamp slip test was performed with galvanized steel reference tubing, but significant distortion of the tubing occurred before any significant distortion of the clamp, therefore the subsequent tests were conducted using a steel reference bar. The first set of 4 right angle clamp distortion tests resulted in individual result variations greater than 15% from the calculated average, so another set of 4 tests was completed to satisfy the CSA specification. In general, the pins at the collars of the clamps showed the greatest amount of distortion (Figure 2). The maximum loads obtained prior to significant distortion of the right angle clamps are contained in Table 1. For swivel clamp distortion tests, compressive forces were applied to the central clamp while the outer two clamps held the diagonal bar in place. The outer two clamps were fixed around welds on their respective vertical bars in order to keep the outer clamps stationary with respect to the test fixture. Figure 3

Slip tests were also performed in accordance with Section 11.3.3.2 of CSA S269.2. Each slip test was set up in according to the force diagrams in CSA S269.2 Figures 4 and 6. Test assemblies were similar to those shown in Figures 1 and 2. The right angle slipping test is similar to the distortion test except that slipping of the clamp along the vertical tube prior to distortion of the assembly is observed during the slip test. The swivel clamp slip test is also similar to the distortion test; however during the slip test, compressive forces are applied to the top of the central vertical tube rather than to the central clamp, which allows the potential for the vertical tube to slip within the central clamp. Maximum loads obtained prior to observable slipping are shown in Tables 3 and 4. In accordance with CSA S269.2, a reduction factor of 2.5 was applied to the average slip loads to calculate the design capacities.
